TECHNICAL SERVICE BULLETIN: 1.5in. Capstan Cable Guard, Rev B

Original Bulletin: November 17, 2022

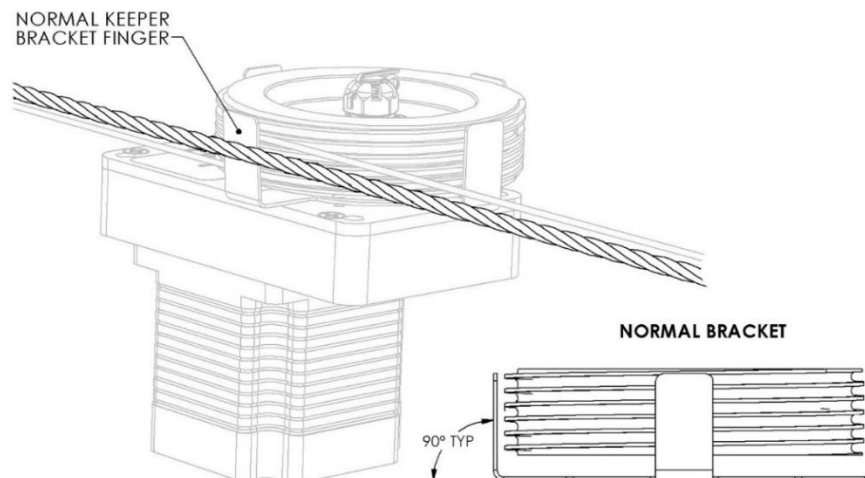
CORRECT CONTROL CABLE POSITION OUTSIDE KEEPER BRACKET FINGERS

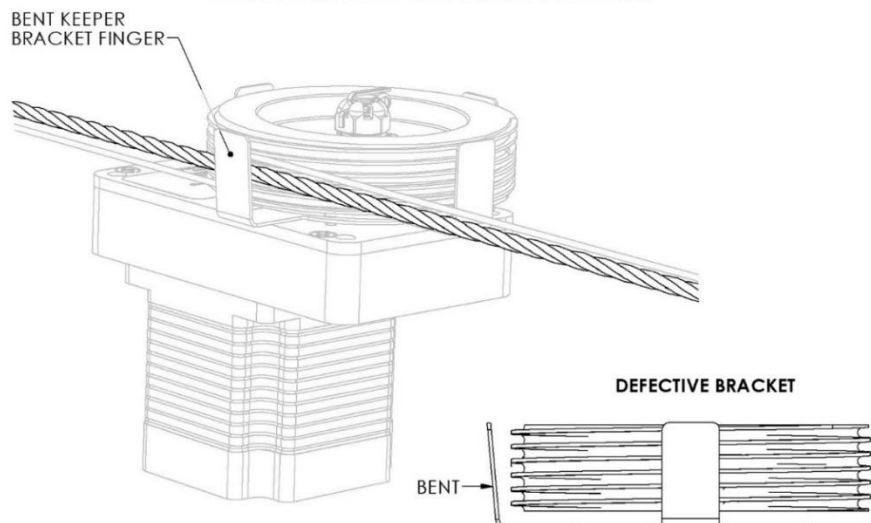
The fingers of the cable guard for the pitch servo's 1.5in. capstan used on Bonanza 35 and 36 models can be bent, potentially creating an out-of-specification gap between the capstan and the guard. This gap may allow the elevator control cable to jump over the capstan guard, positioning itself between the capstan and the cable guard (see figure below).

INCORRECT CONTROL CABLE POSITION INSIDE KEEPER BRACKET FINGERS

1. Prior to next flight, and every 25 hours thereafter, perform a visual inspection of the pitch servo installation to verify the elevator cable is not positioned between the capstan and cable guard. This action may be performed by the owner/operator (pilot) holding at least a private pilot certificate.

- c. If the elevator control cable has positioned itself between the capstan and the cable guard, notify Dynon Technical Support.
2. Within 12 months after the effective date of this service bulletin or 100 flight hours, whichever comes first, replace the pitch servo's capstan guard with a new Dynon-provided product (P/N 103535-001). To request the part, fill out and submit the following form: [Service Bulletin Cable Guard Request Form](#).

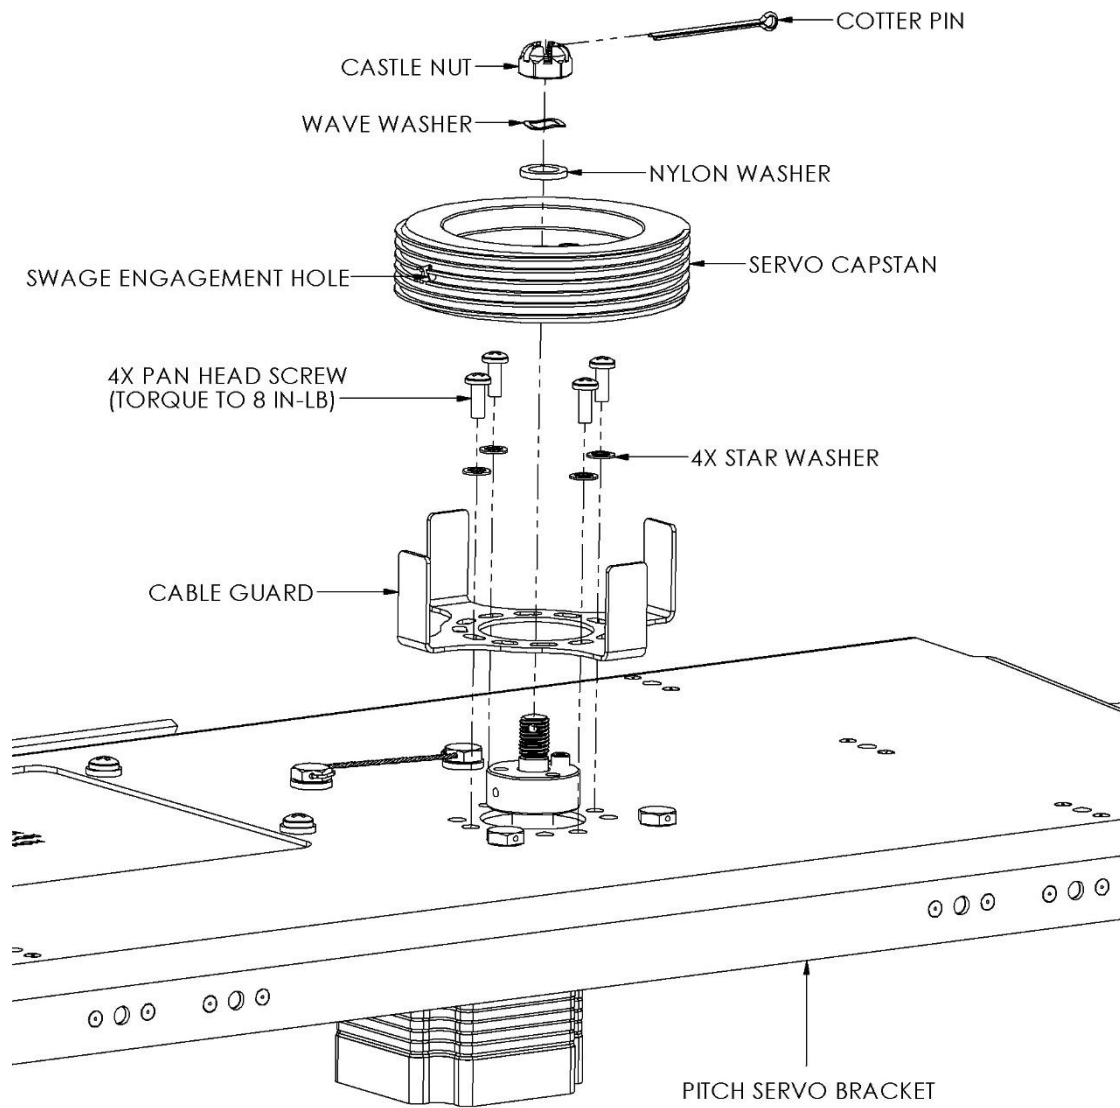
BRIDLE CABLE REMOVED FOR CLARITY

Reference the figure below when performing the following procedure.

- m. Remove screws and star washers that secure capstan guard to servo.
- n. Remove old and replace with new capstan guard.
- o. Secure capstan guard to servo with screws and star washers.

- p. Place capstan onto output shaft, aligning hole in capstan with shear screw head located in servo disc. Make sure swage engagement hole is in same position as noted in step 'f'.

- r. Finger-tighten castle nut onto servo shaft, and then use a wrench to tighten until slot in castle nut lines up with hole for cotter pin in servo shaft.
DO NOT overtighten the castle nut! Tightening castle nut beyond 4 in-lbs may prevent the capstan from rotating freely in event of shear screw failure.
